Draft Environmental Impact Statement

**Amsterdam Materials Recycling Project
Edson Road
City of Amsterdam, Montgomery County, New York**

**VOLUME 3
APPENDICES D-K**

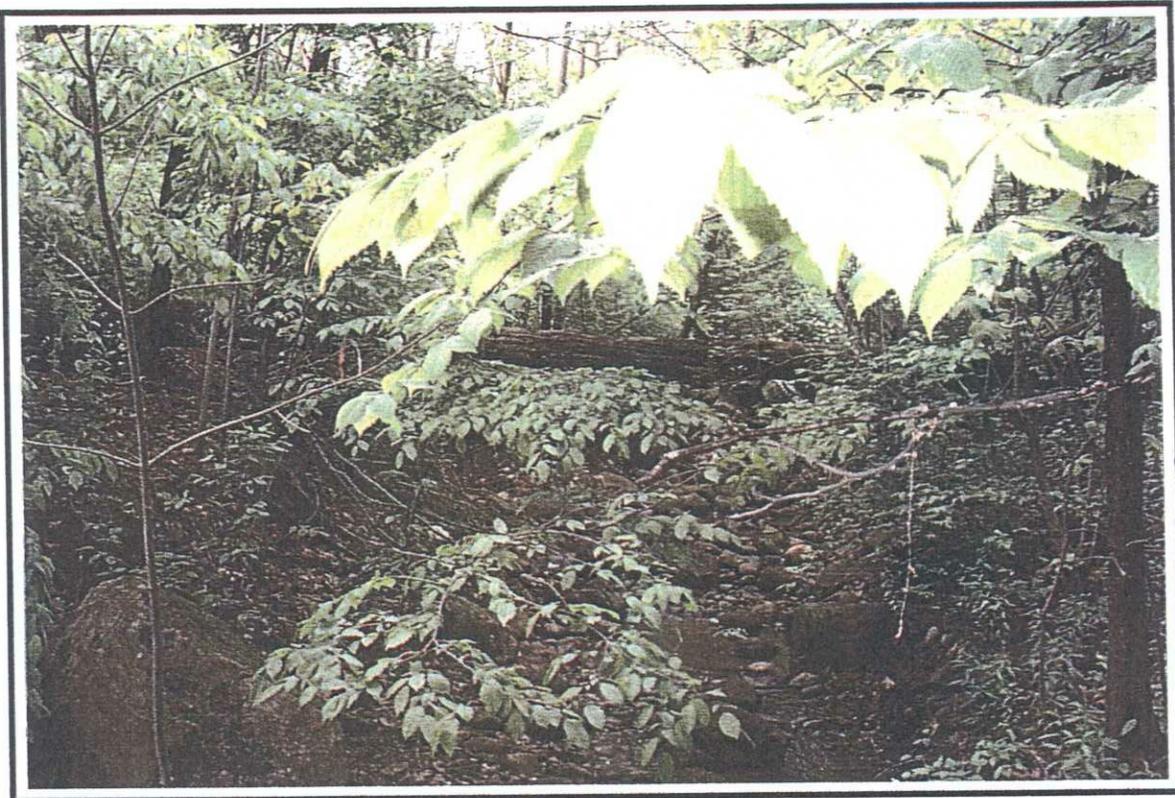
Photo #1

Description: View looking north along from the center line of wetland D. Note the lack of vegetation and the rock and stone covering the ground.
